# UNDERWATER BRIDGE INSPECTION REPORT

STRUCTURE NO. 94246

MISSISSIPPI RIVER

JOB NO. 3512 (CEI 18A)

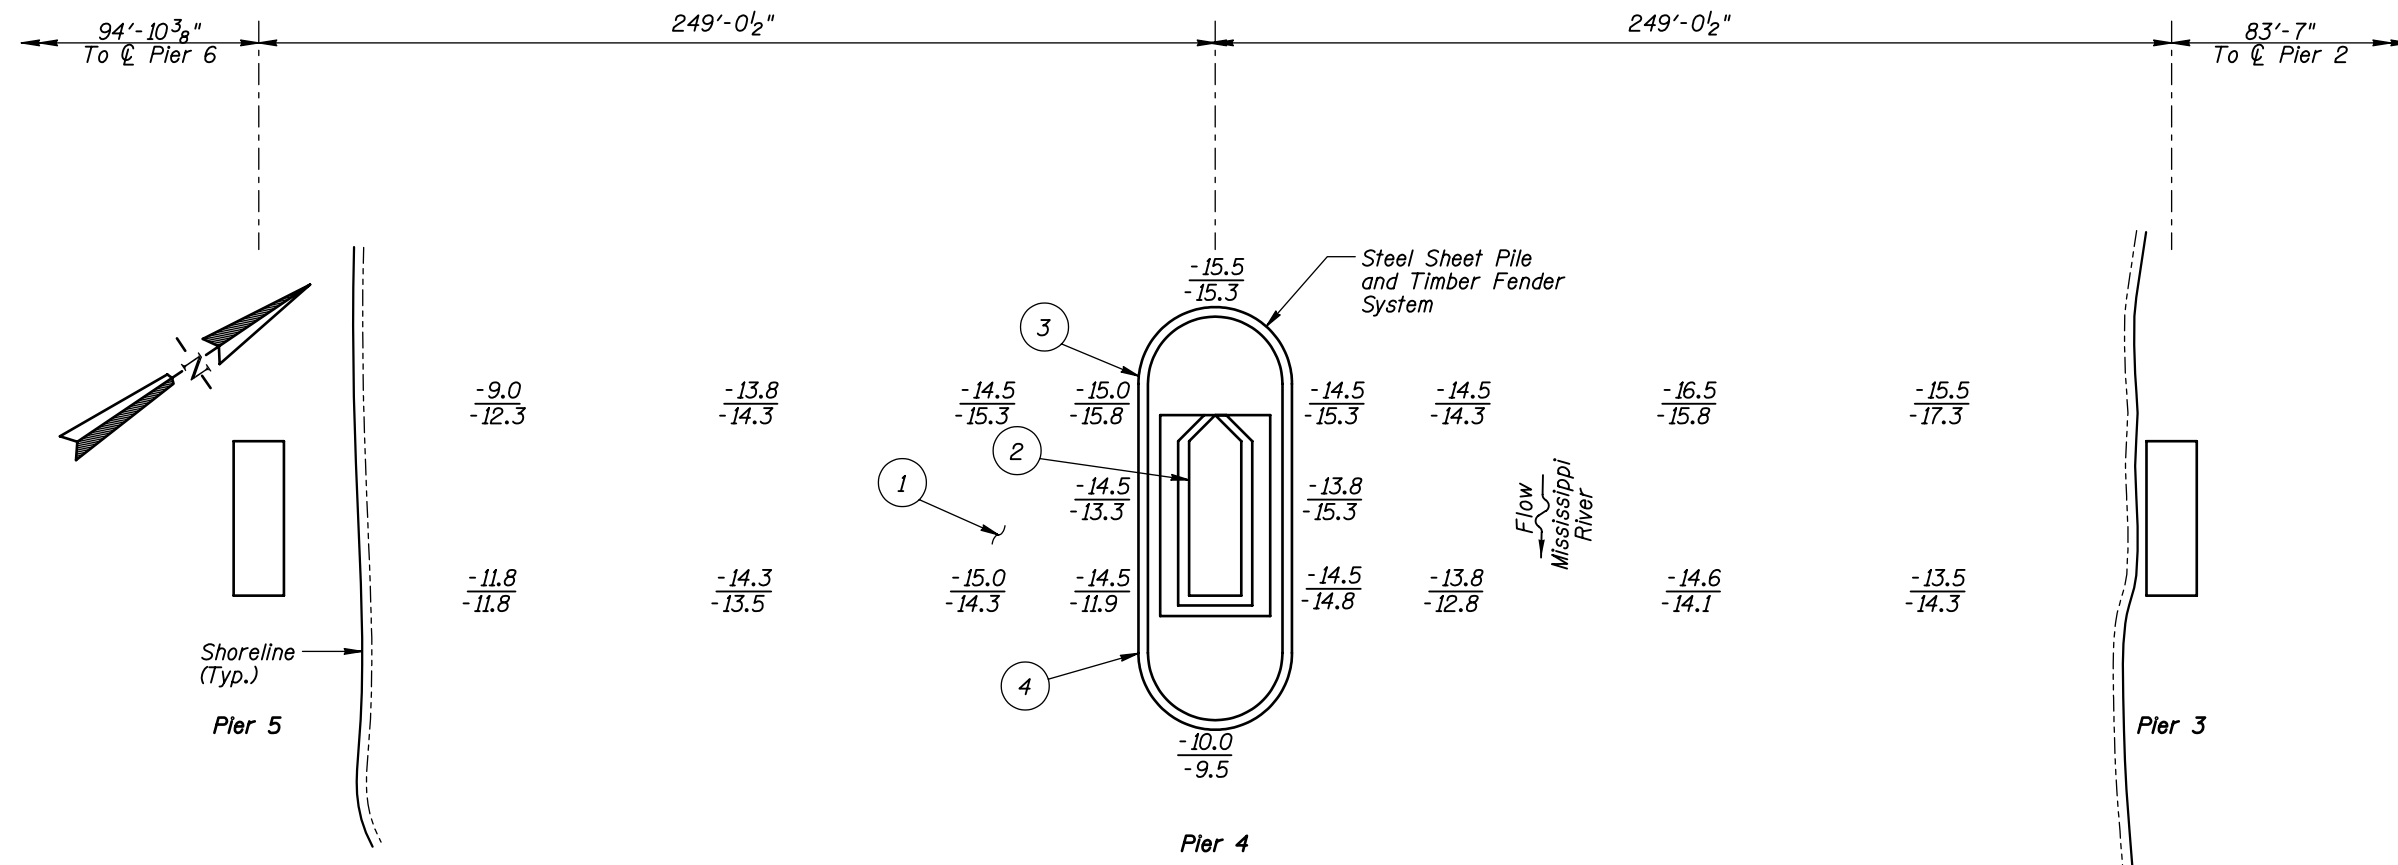
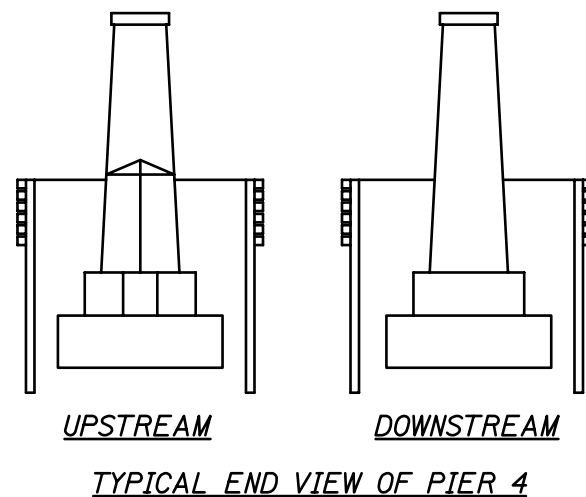
**INSPECTION AND SOUNDING PLAN**

1. The channel bottom material consisted of sand, gravel and areas of riprap, 3 feet diameter and smaller, with 2 inches of probe rod penetration.
2. The above water concrete was in satisfactory condition with random minor section loss having up to 2 inch penetrations, random map cracking with efflorescence and rust staining.
3. The steel sheeting encasing the concrete pier below water displayed a 1/8 inch layer of surface corrosion, random 1 inch diameter rust nodules, and random 1/8 inch deep pitting.
4. Fender system timber whalers were in fair to poor condition with some areas of decay and rot at the waterline and several failed connections. Moderate impact damage was evident in several locations around the pier perimeter.

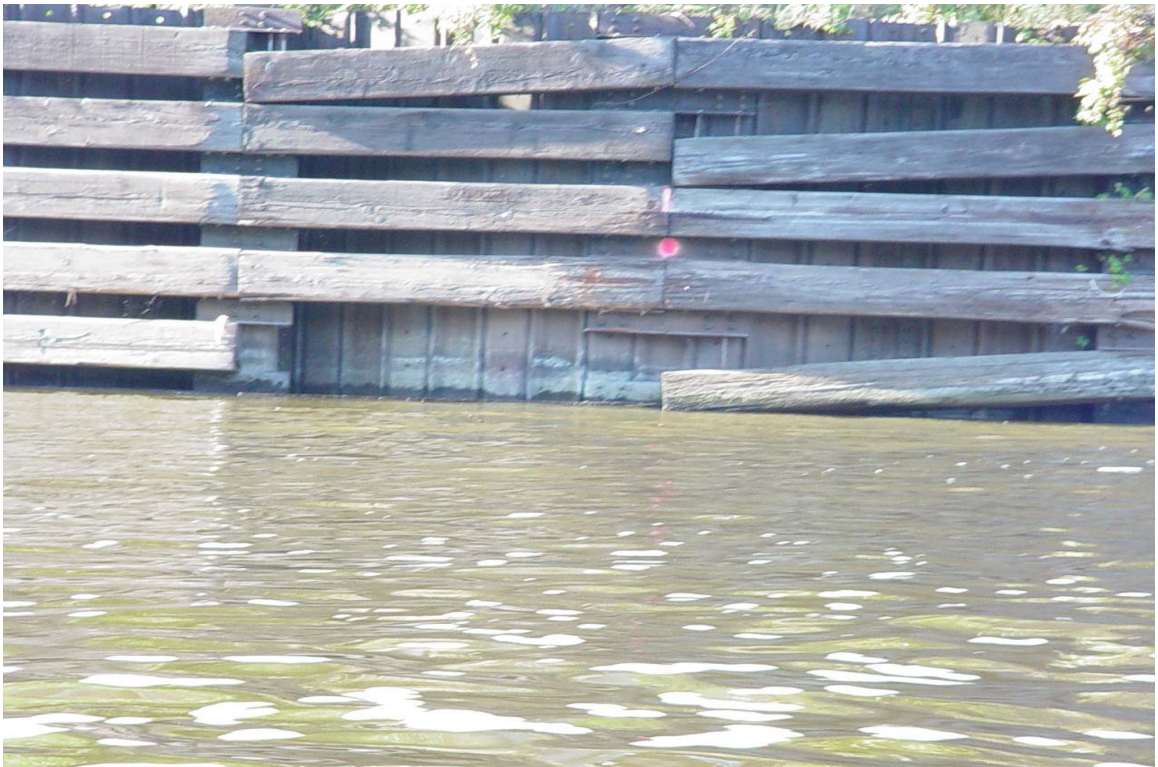
- (A) The steel sheeting encasing the concrete pier below water displayed a uniform 1/8 inch layer of surface corrosion, random 1 inch diameter rust nodules, and random 1/8 inch deep pitting.
- (B) The timber fenders showed signs of moderate decay and rot at the waterline along with some failed connections and impact damage.

Photograph 4. View of the Damaged Fender System of Pier 4, Looking South.

- (A) Depending on the proposed future use of the structure, consideration can be given to replacing the deteriorated and damaged timber walers and fender components during normal maintenance operations.
- (B) Reinspect the submerged substructure unit at the normal maximum recommended (NBIS) interval of five (5) years.
